National Sedimentation Laboratory
Channel and Watershed Processes Research Unit
Oxford, Mississippi

Acoustic Imaging of Sediment Impounded Within USDA-NRCS Flood Control Dams, Wisconsin

Research Report No. 30

August 2002

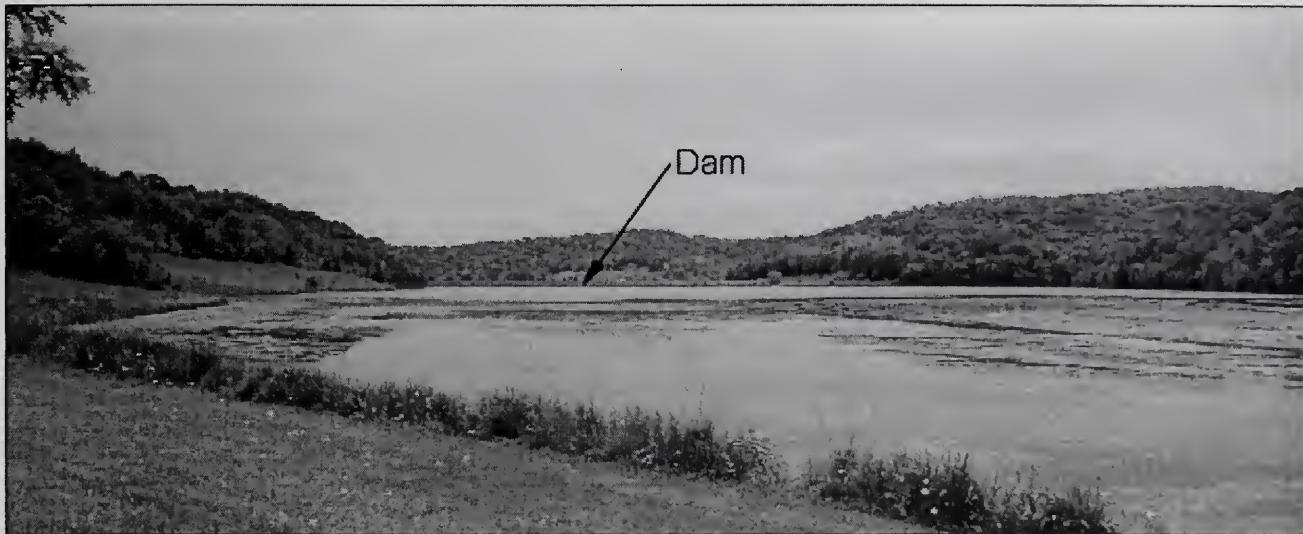
Figure 2-3. The photograph of White Mound Lake taken from the boat ramp area and facing south. Areas of the lake with 4 m of water depth or less contain aquatic vegetation that extends from the bottom to the lake surface as shown in distance.

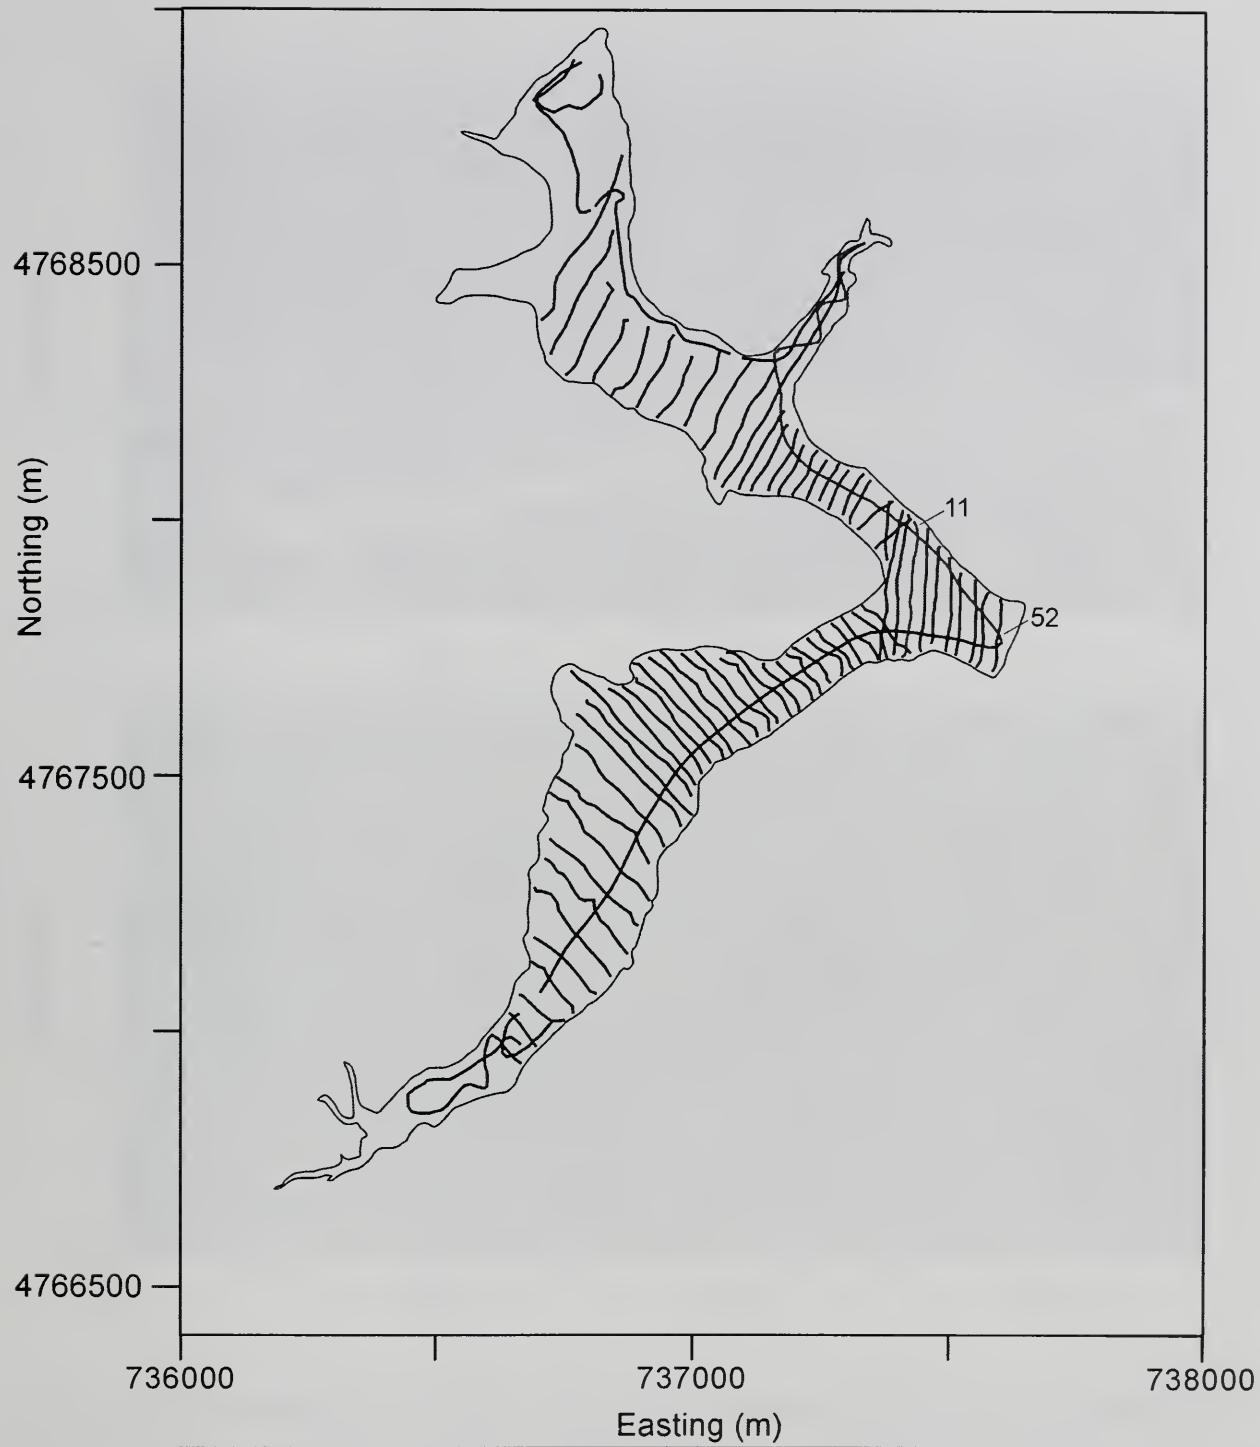
The survey of Twin Valley Reservoir was conducted on May 30, 2002. The survey began by collecting track lines across the main body of the reservoir near the dam at 25 m spacing. Line-spacing was then switched to 50-m for the tributary arms, in order to complete the survey in one day (Figure 4-1).

Figure 4-1. Profile map of Twin Valley Lake acoustic survey. The survey contains 17 km of profile lines. Profiles 11 and 52, highlighted in red, are shown as example profiles in accompanying figures. Coordinates are in meters (UTM Zone 15).

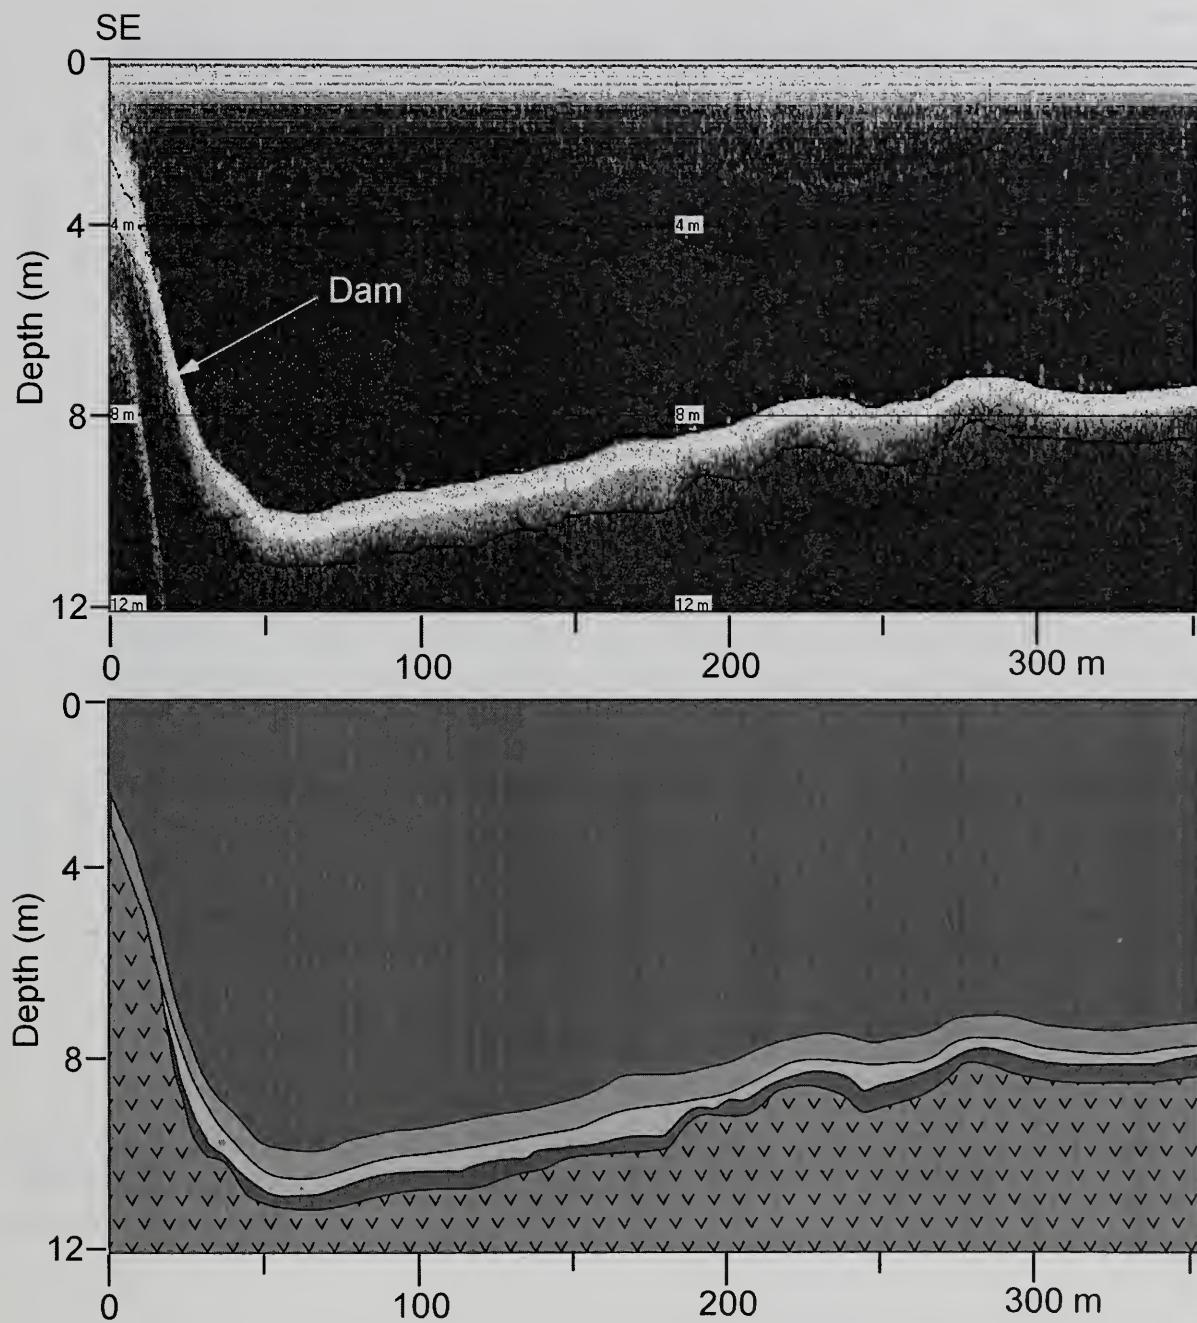
The acoustic response of sediments onlapping the dam face show three distinct acoustic layers (Figure 4-2). The upper-most layer appears white on the multifrequency displays, indicating scattered returns from all three frequencies. Such a response commonly corresponds to fine-grain, water-rich sediments. This layer has a nearly uniform thickness, 0.3 to 0.4 m, throughout the reservoir and appears to drape bottom topography. The layer beneath the first appears light blue in the false-color display, indicating returns from the 48 and 24 kHz signals, but not the 200 kHz. This interval preferentially fills the lows and channel axes, is 0.6 m thick near the dam, and thins upstream (Figures 4-2 and 4-3). In the upper reaches of the tributary arms, the light blue layer is only present at the base of the channel axes. The bottom-most layer deposited on the dam face appears dark blue, indicating returns from only the 24 kHz signal. This interval is relatively thin (0.1 to 0.2 m) over most of the reservoir, but reaches considerable thickness in the channel axes.

Figure 4-2. Southeast end of Twin Valley Lake axial profile, Line 52 (see Figure 4-1 for line location). Three acoustic intervals are seen within the sub-bottom in Twin Valley Lake. All three onlap onto the dam face. Hence, all three must be part of the post-impoundment sediment fill package.

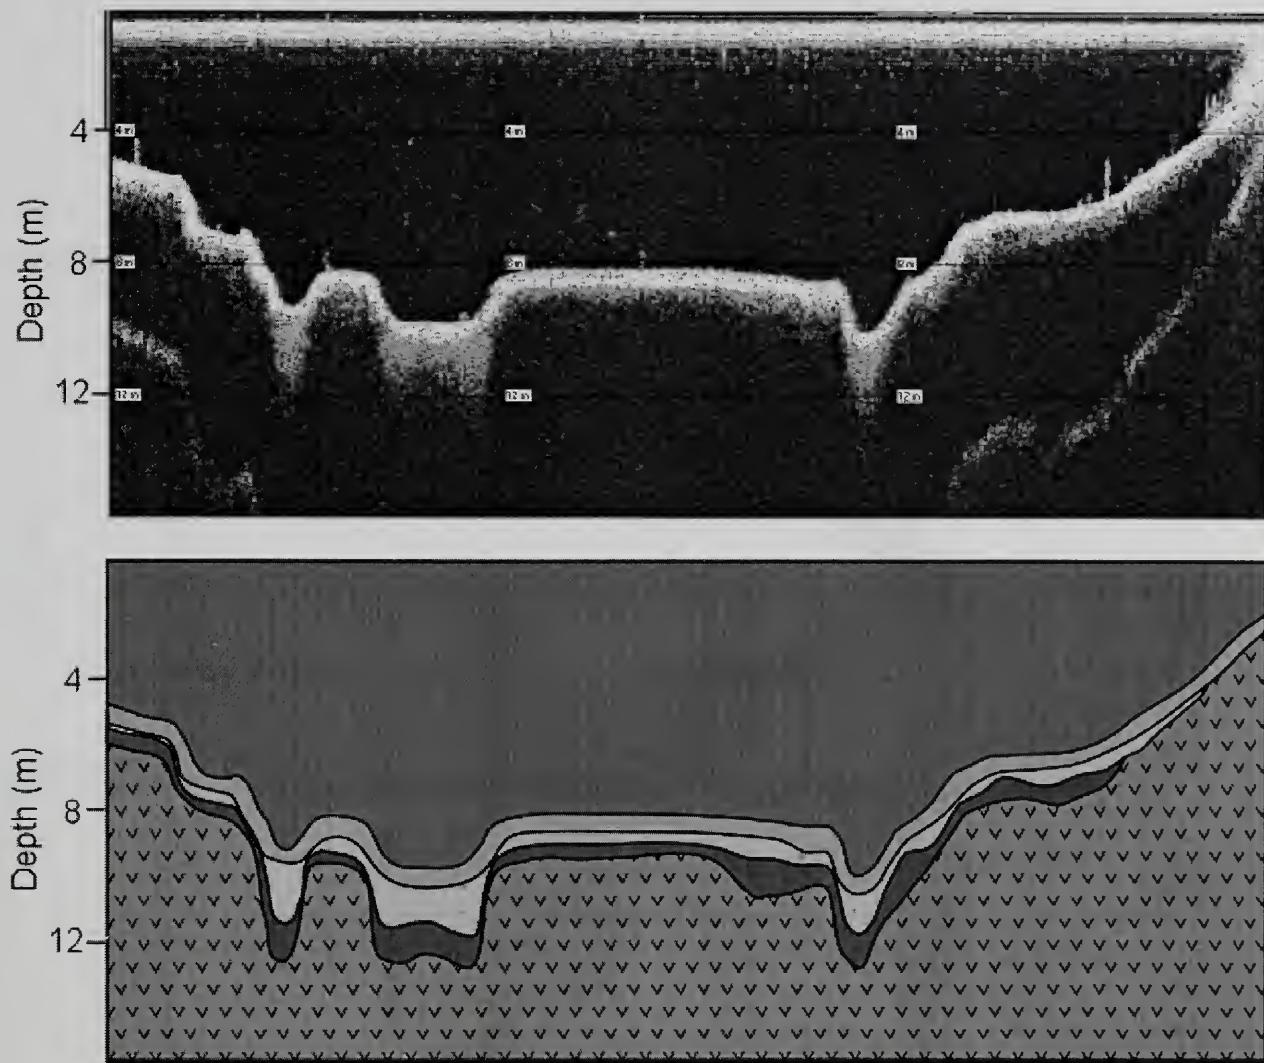
Figure 4-3. Processed Line 11 with interpretation (see Figure 4-1 for line location).
The multifrequency acoustic profiles show three distinct sediment layers within the post-impoundment fill.

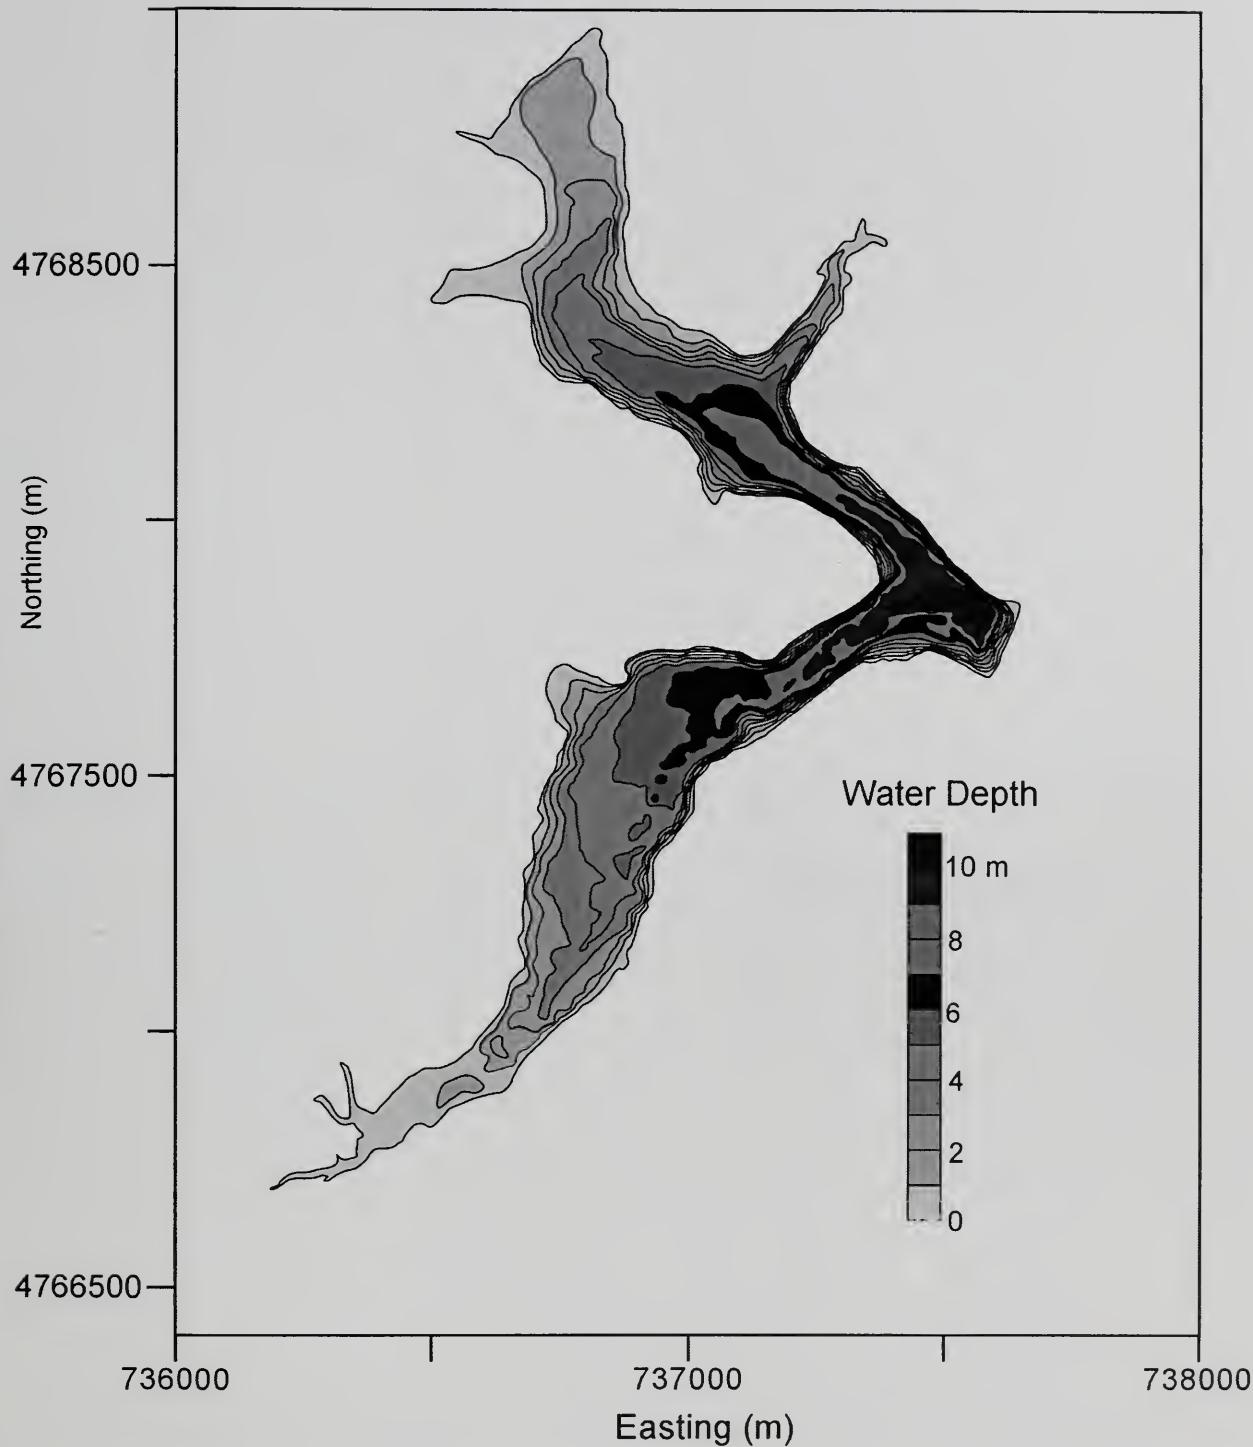
The resulting map of the water depth indicates a maximum depth of 10.2 m (33.4 ft) near the dam and a total current water capacity of 2,089,500 m³ (1693.6 acre-ft; Figure 4-4). The sediment isopach map indicates a maximum thickness of 3.1 m, in a small area along the main channel axis, and a total volume of post-impoundment sediment of 458,659 m³ (371.8 acre-ft; Figure 4-5).

Figure 4-4. Contour map of water depth in Twin Valley Lake, WI. Depth is measured from the water surface at an elevation of 277.4 m (910 ft). Coordinates are in meters (UTM Zone 15).

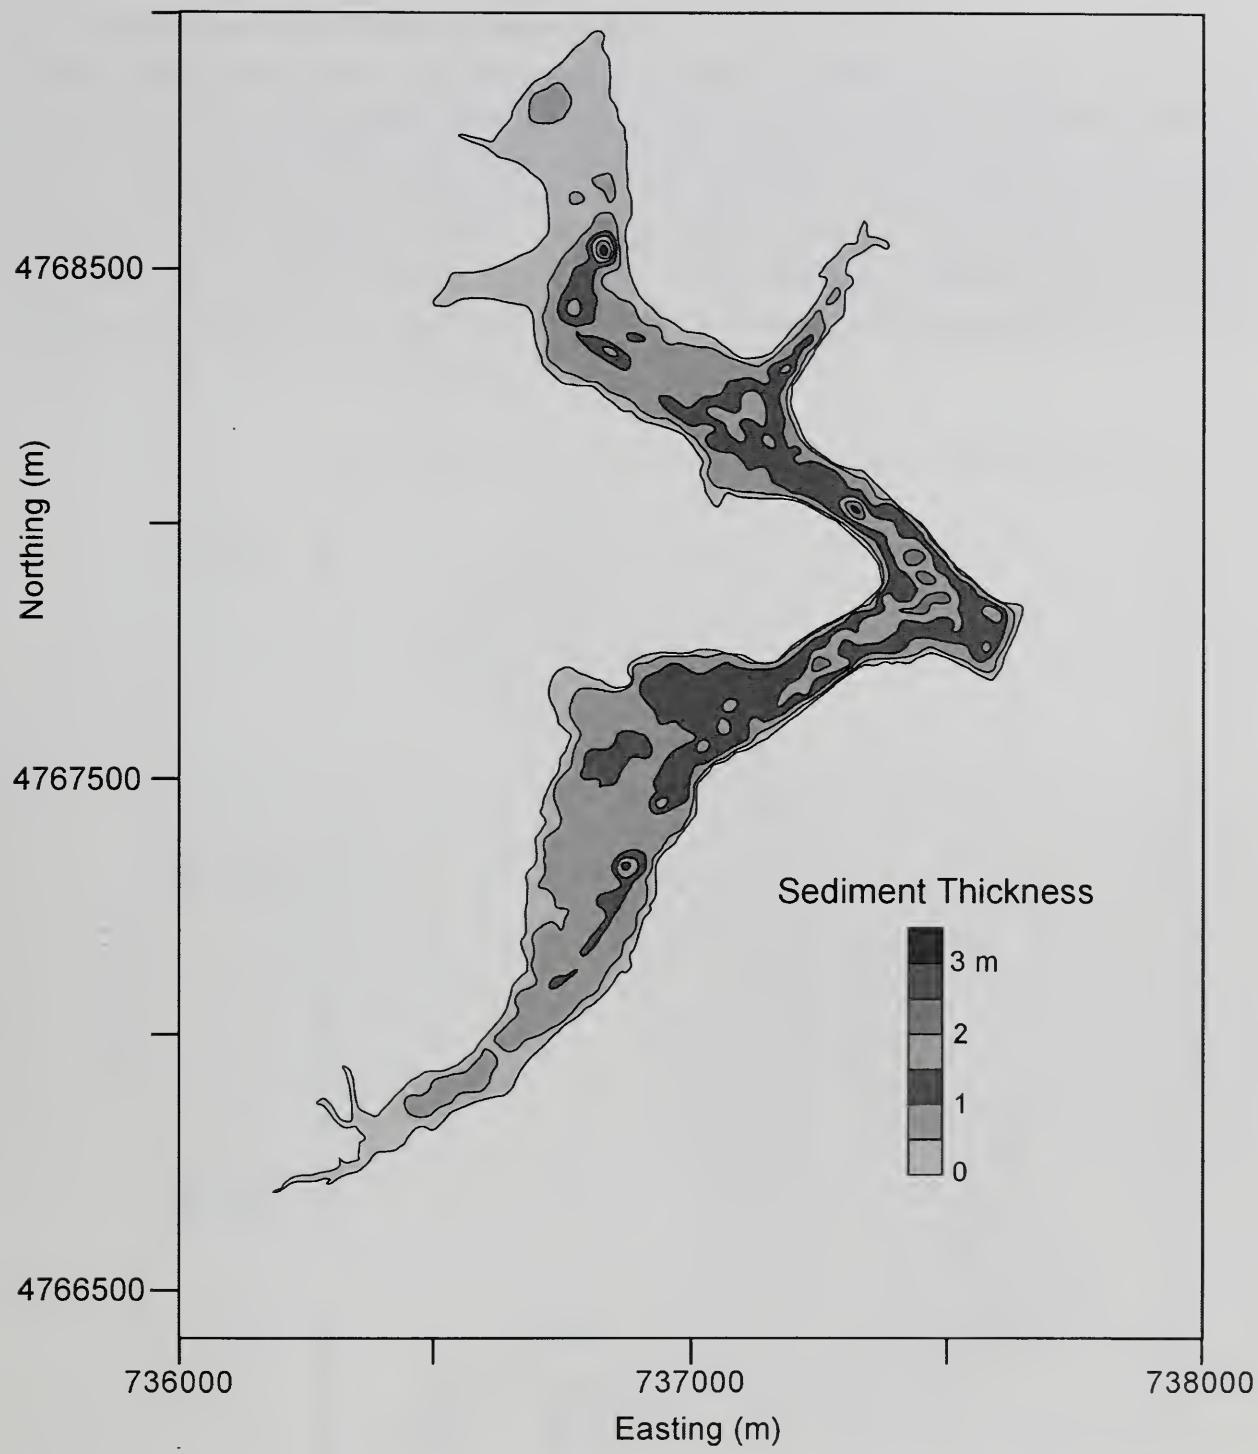
At Twin Valley Lake, the sediment isopach map indicates a maximum thickness of 3.1 m, in a small area along the main channel axis, and a total volume of post-impoundment sediment of 458,659 m³ (371.8 acre-ft). At White Mound Lake, the sediment isopach map indicates a maximum thickness of 1.4 m (4.6 ft) and a total volume of post-impoundment sediment of 203,205 m³ (164.7 acre-ft). These values represent conservative estimates of sediment accumulation without corroboration with ancillary data.

Figure 4-5. Contour map of sediment thickness in Twin Valley Lake, WI. Sediment thickness is measured from the water bottom to the interpreted base of post-impoundment fill. Coordinates are in meters (UTM Zone 15).

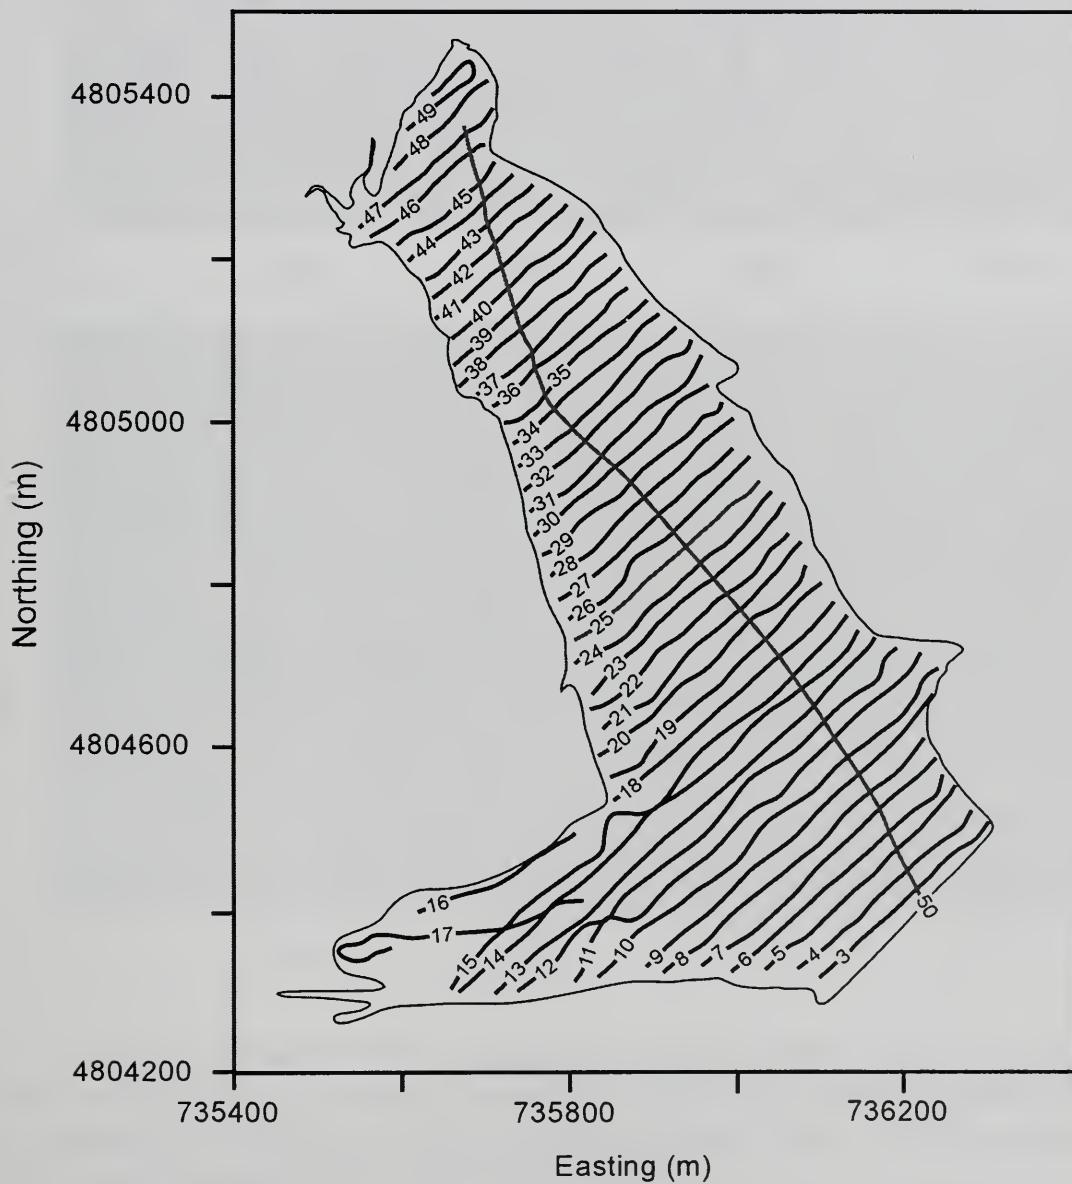
White Mound Reservoir was surveyed on May 31, 2002. The entire survey was conducted with a 25-m track line spacing (Figure 4-6). Acoustic intervals similar to those seen in Twin Valley Lake were observed in White Mound Lake onlapping onto the dam face (Figure 4-7) and thinning upstream (Figure 4-8). The resulting maps indicate a maximum water depth of 8.6 m (28.3 ft) and a current water storage capacity of 1,462,460 m³ (1,185.4 acre-ft; Figure 4-9). The sediment thickness map indicates a maximum thickness of 1.4 m (4.6 ft) and a total volume of post-impoundment sediment of 203,205 m³ (164.7 acre-ft; Figure 4-10).

Figure 4-6. Profile map of White Mound Lake acoustic survey. Profiles 25 and 50, highlighted in red, are shown as example profiles in accompanying figures. Coordinates are in meters (UTM Zone 15).

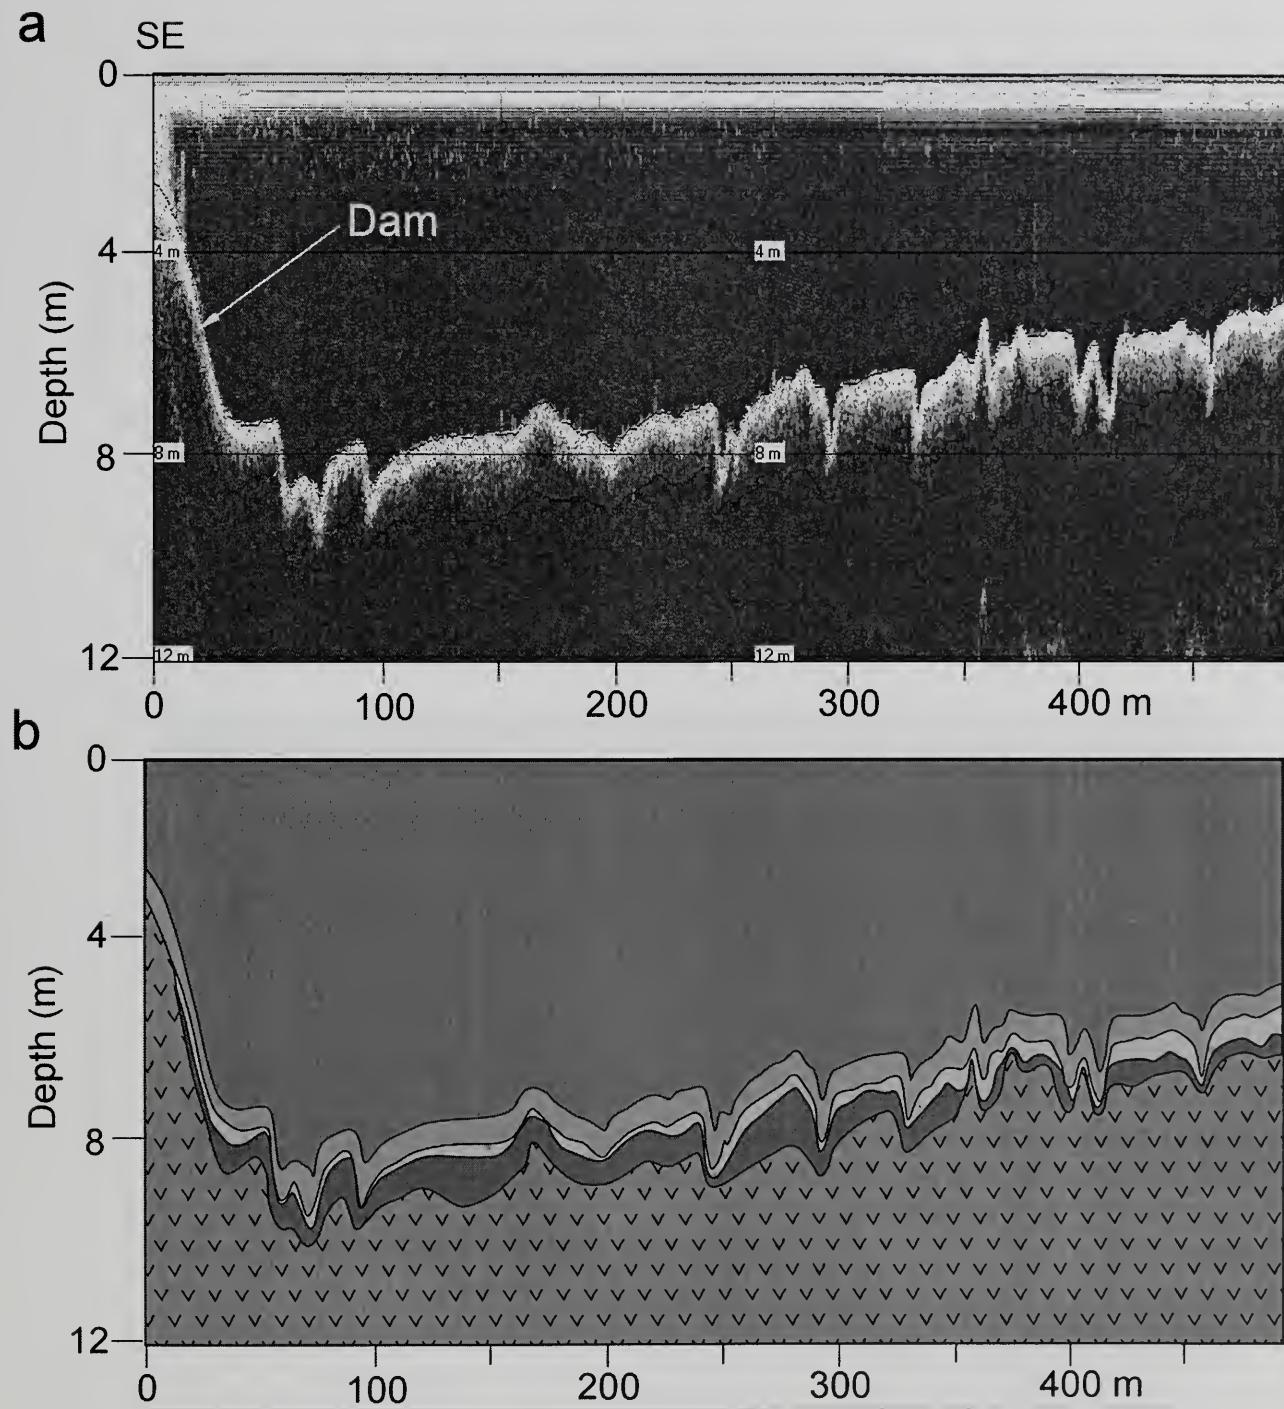
Figure 4-7. Southeast end of White Mound Lake axial profile, Line 50 (see Figure 4-6 for line location). Three acoustic intervals are seen within the sub-bottom in White Mound Lake. All three onlap onto the dam face. Hence, all three must be part of the post-impoundment sediment fill package.

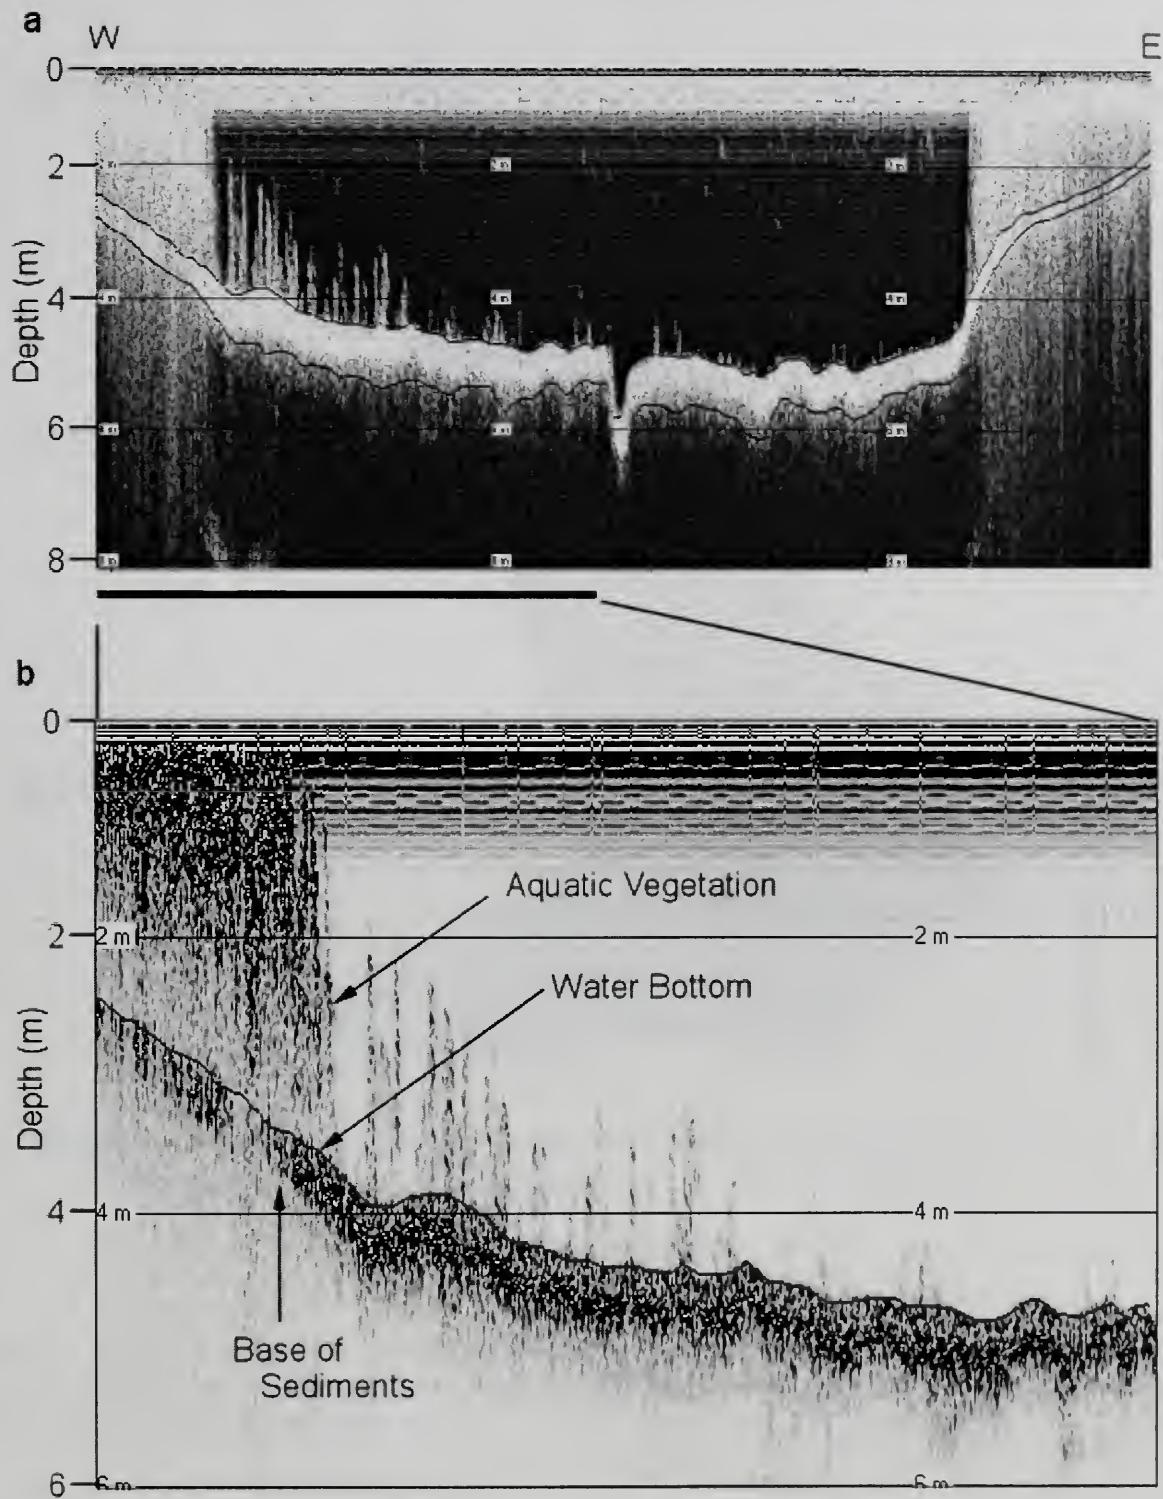
Figure 4-8. Acoustic profile 25 of the White Mound survey (see Figure 4-6 for line location). (a) Multifrequency display in which 200 kHz is red, 48 kHz in green and 24 kHz is blue intensity in the RGB image. The interpreted top and base of the post-impoundment fill are marked with black lines. (b) Aquatic vegetation blocks the 200 kHz signal, but is relatively transparent to the 48 kHz signal.

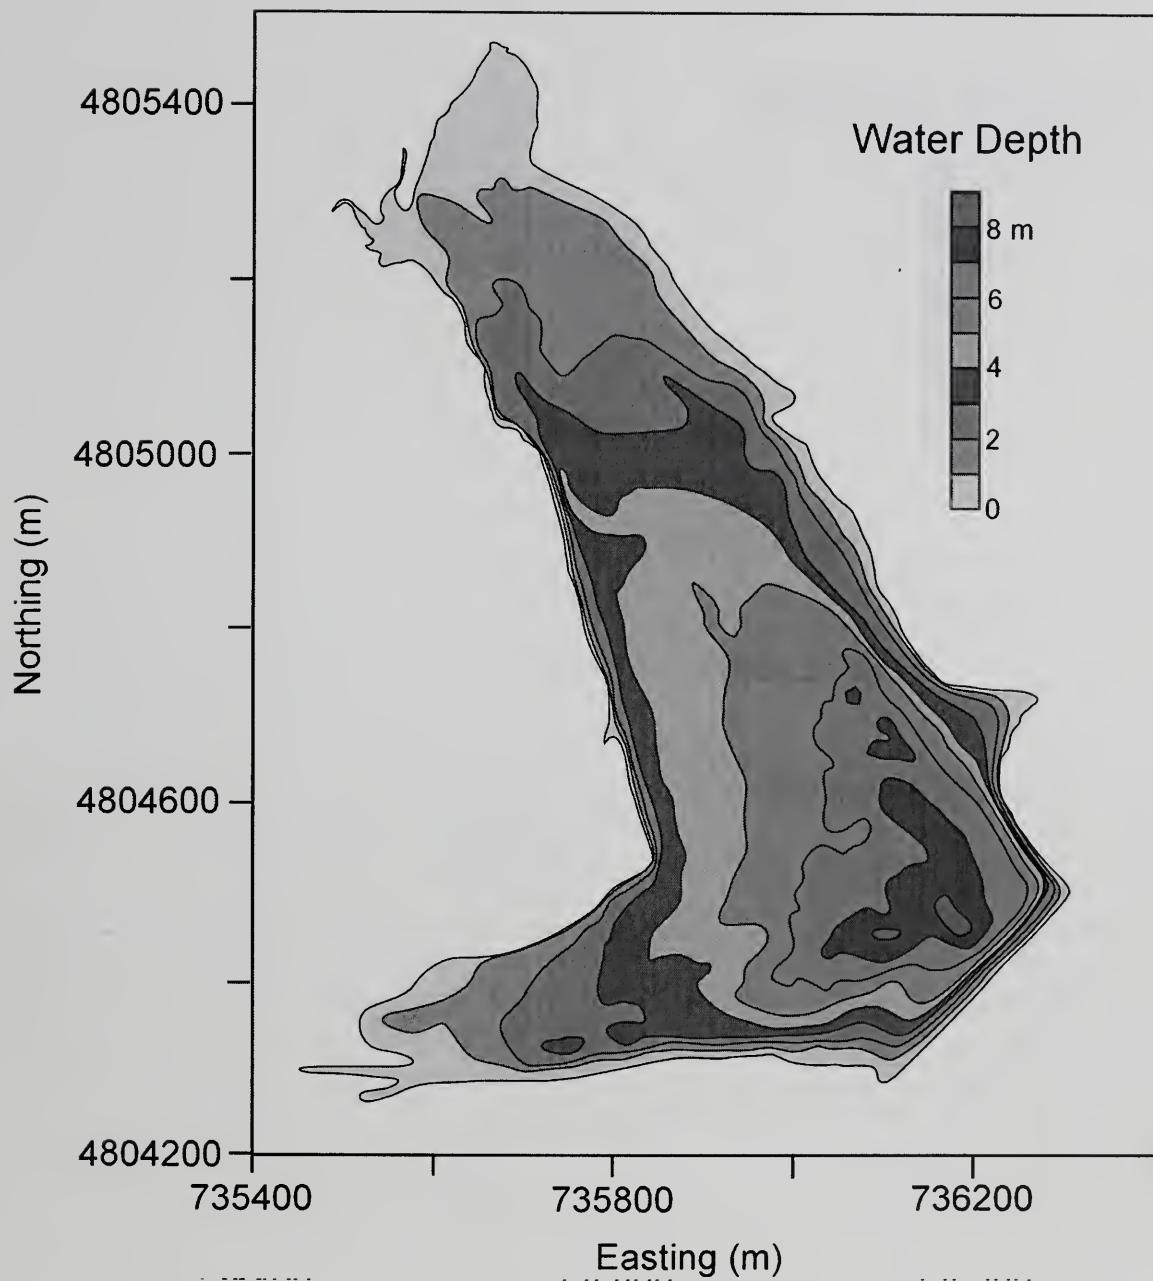
Figure 4-9. Contour map of water depth in White Mound Lake, WI. Depth is measured from the water surface at an elevation of 278.4 m (913 ft). Coordinates are in meters (UTM Zone 15).

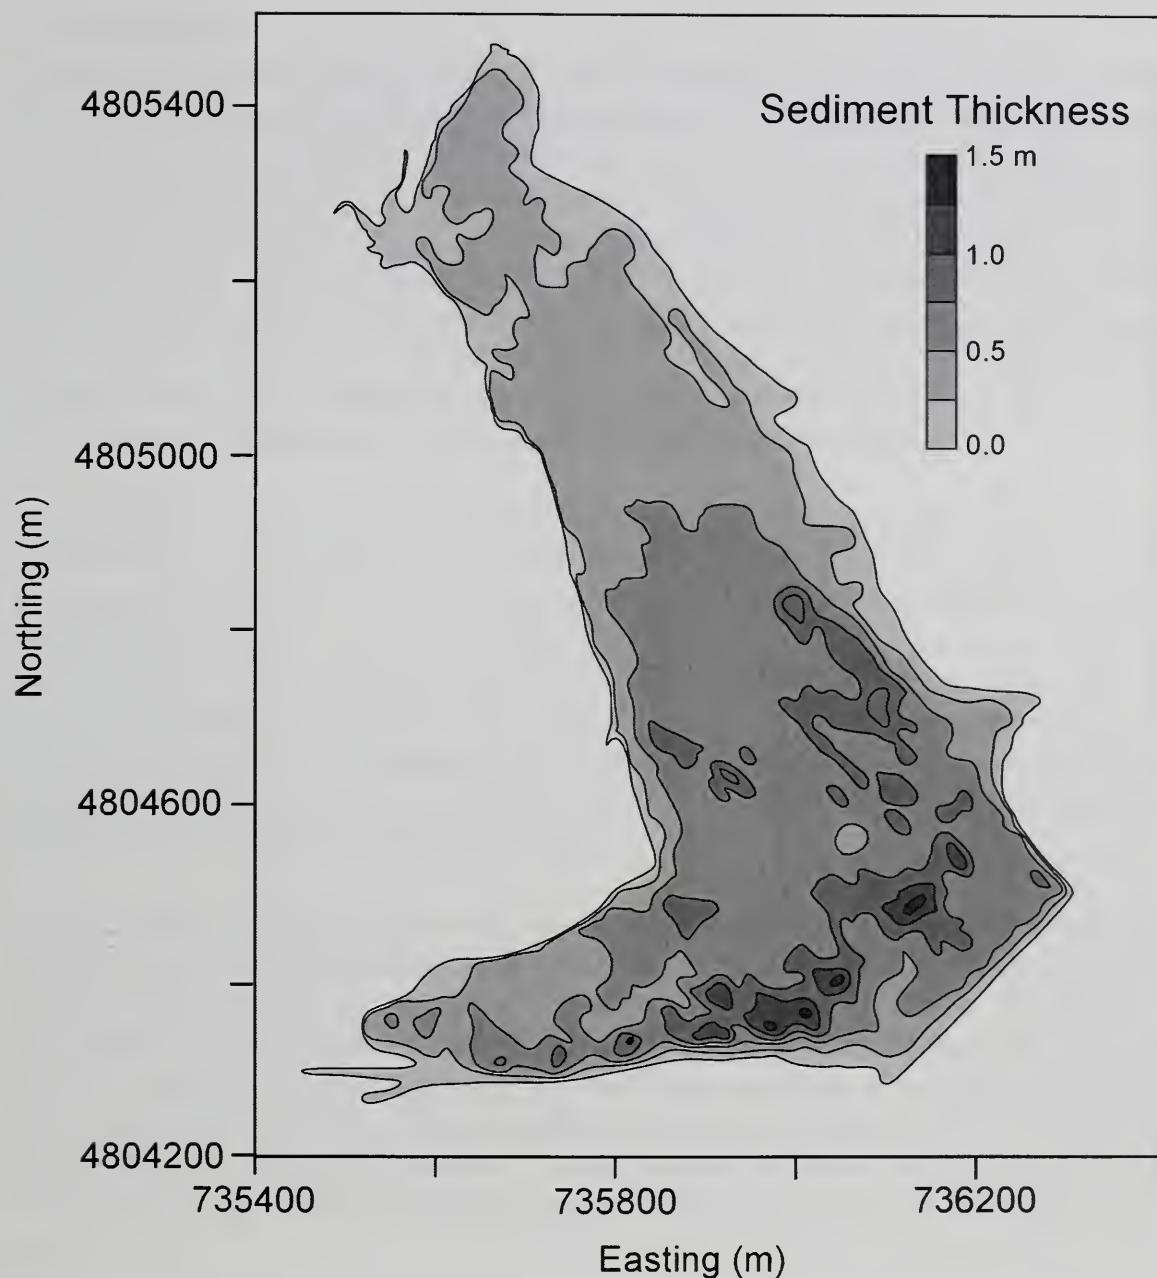
Figure 4-10. Contour map of sediment thickness in White Mound Lake, WI.
Sediment thickness is measured from the water bottom to the interpreted base of post-impoundment fill. Coordinates are in meters (UTM Zone 15).
